STAIR WIDTH REQUIREMENTS FOR COMMUNAL AREAS IN FLATS

PREFORMED LINTEL CAVITY TRAYS

CLAIMS LEARNING: BOX GUTTERS

KNOWLEDGE REFRESH: LATERAL RESTRAINT OF GABLES

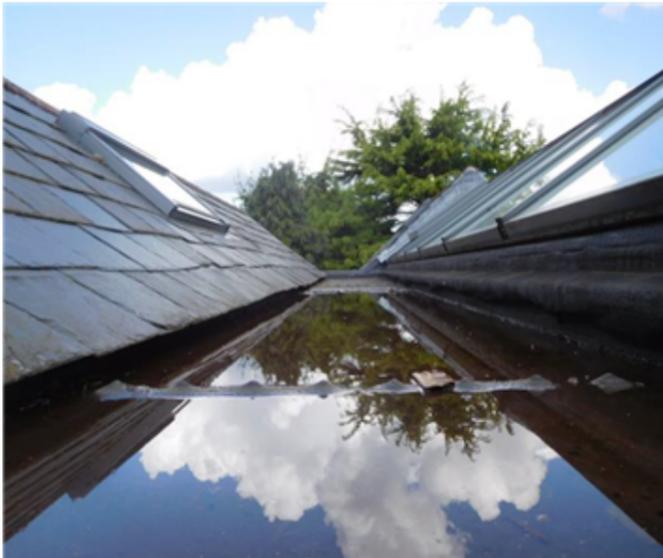
The secret box gutters to each side of the atrium have been constructed with inadequate falls, with virtually no upstand to either side of the gutter. The outlets are inadequate to cope with the volume of water discharging from the adjacent roofs into the secret box gutters and therefore, under periods of heavy rainfall, the gutters flood up over the inadequate upstands and the water tracks into the property. The image to the left shows the lack of fall and ponding of the gutters.

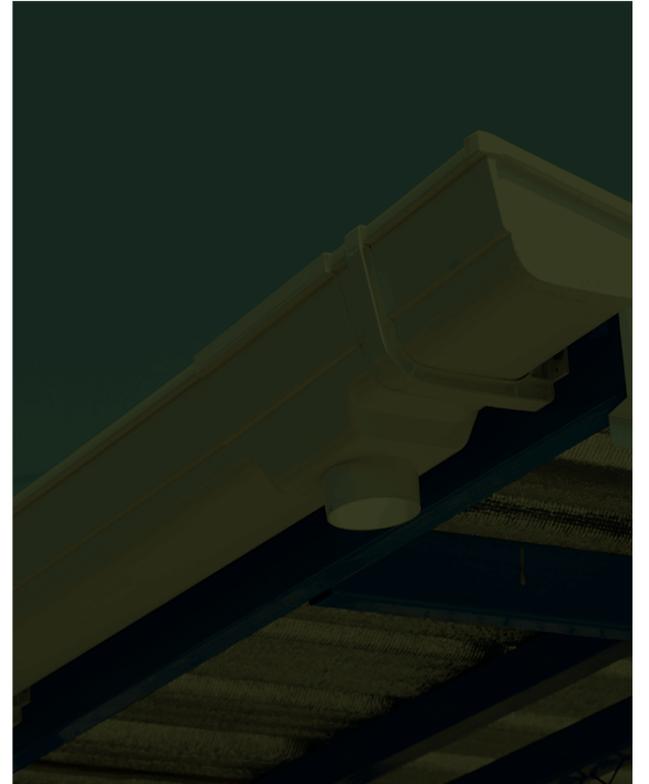
There have been a number of attempts to repair the secret box gutters as can be seen by this image, but fundamentally the roof needs to be stripped in the vicinity of the secret box gutters and new box gutters constructed with adequate upstands, falls and drainage outlets.

During the investigation into the leaking roof, inspections showed very poor workmanship generally when the roof was recovered. In particular, the standard of workmanship in the vicinity of the secret gutter was extremely poor.

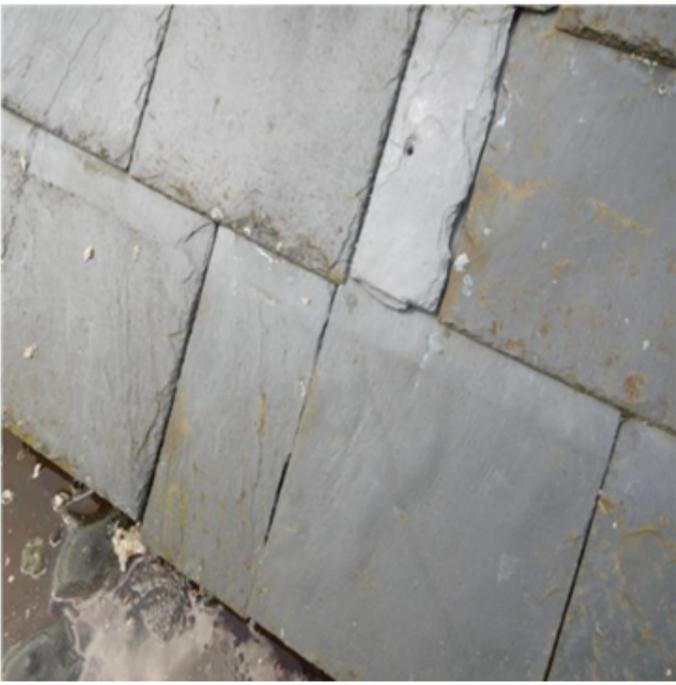
When the original secret box gutter was designed, it should have been regarded as a flat roof interface to pitched roof. The **Premier Guarantee Technical Manual 7.10.9.1:** Figure 7 shows a typical detail. This would have given a minimum 150mm upstand to the box gutter.

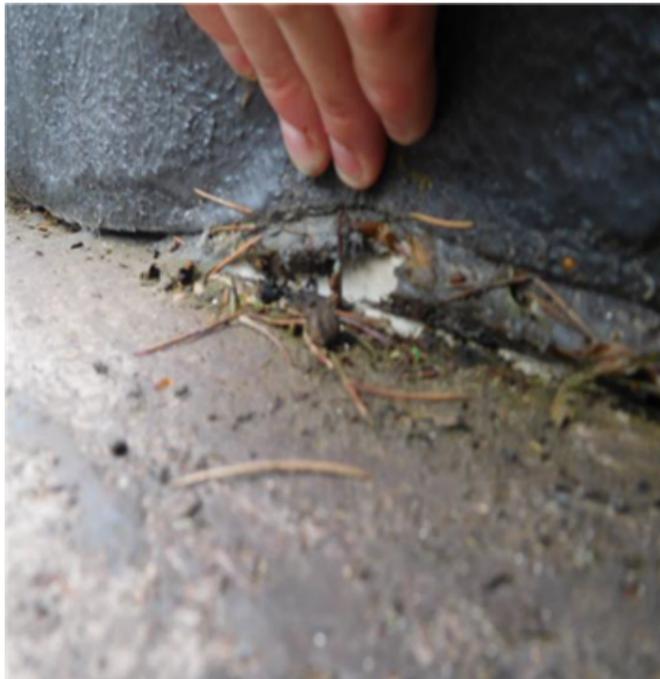
Of drainage of flat roofs, section 7.10.5 of the Premier Guarantee Technical Manual states:

“Drainage design should be based upon calculations in accordance with BS EN 12056 Part 3 given a design head of water (typically 30mm). Rain water outlet capacity should be taken from properly certificated information provided by manufacturers, and the resulting number and layout of outlets should allow for obstruction and drag due to any additional surface finishes, such as walkways.

It is not generally necessary to provide separate box gutters where two planes of roofing intersect, or where a single plane falls to an abutment. In the latter case, there will be no fall between outlets, so consideration should be given to creating these in the structure or insulation. Box gutters are slow, difficult to construct and introduce unnecessary complexity. The need to maintain a fall in gutters and comply with the energy requirements of the Building Regulations may be difficult to achieve.”

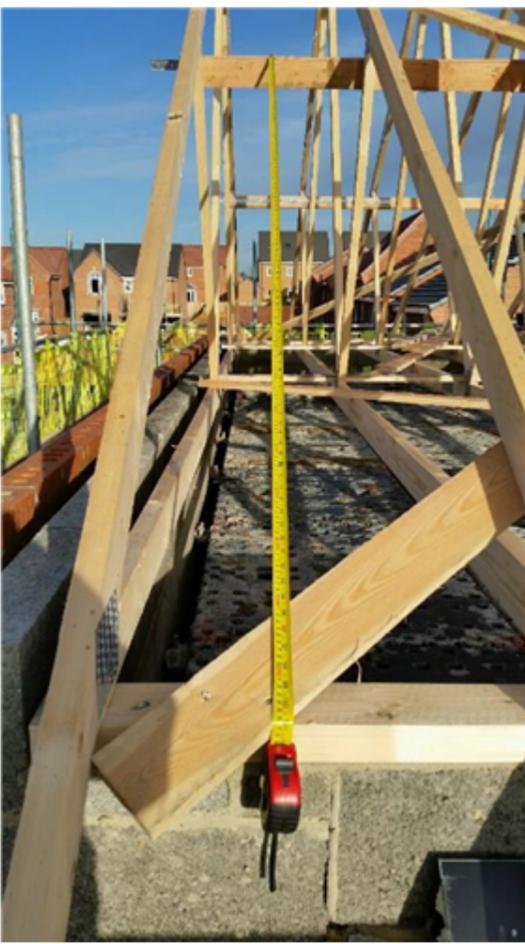
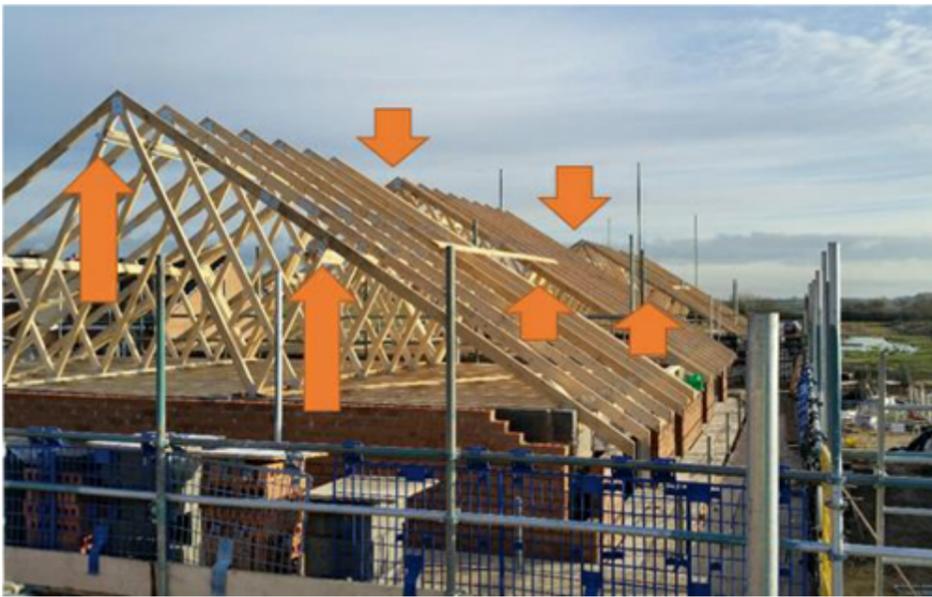
The images below show a row of new properties being built with the roof framing in place, where the distance between the lateral restraint straps could be measured at greater than the maximum 2m centres.

Something to consider is that the Building Regulations and BS 8103 do not stipulate that lateral restraint straps should be provided on the node points/longitudinal bracings only, but that they can be provided anywhere along the rafter line, at maximum 2m centres. It should also be noted that the strap hook should be turned over a full block and not partial or cut blocks.

The practice of only installing lateral restraint straps at node points, regardless of their centres, is something we are seeing more and more of, despite it not meeting the Building Regulations and BS 8103, so it is certainly something to keep an eye on.
