Introduction

Executive summary

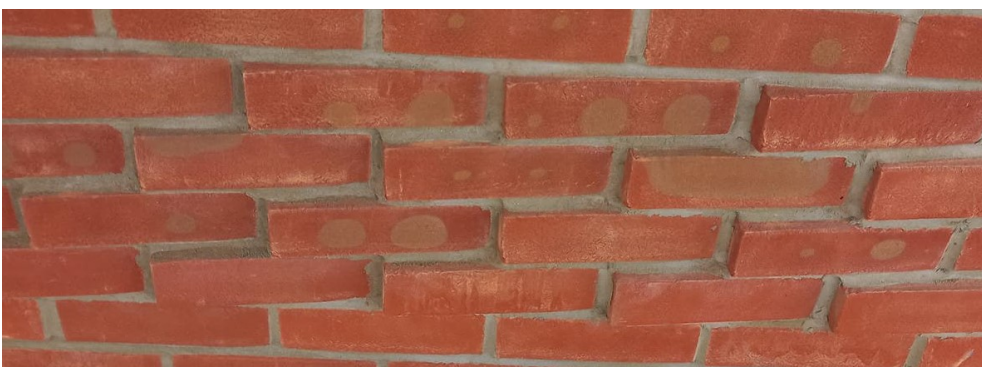
Architectural detailing within brickwork patterns can result in bricks being partly projected out from the face of the wall. Below is an example of a “saw-tooth/wave pattern” where the tops of the bricks project out from the face of the wall. In this particular case, the brick manufacturer confirmed that as result of using this pattern, the lifespan of their brick would be reduced to 30 years from the 60 years anticipated when laid in the traditional manner.

Where the proposed projecting bricks include frogs or perforations, this can have a negative impact upon the integrity and thus durability of the brick, potentially reducing the service life of the brick below the required 60 years as required by our warranty.

In order to ensure that the correct brick is being used for the proposed detailing, the topside exposure of the brick needs to be considered and whether there is a risk of any perforations or frogs becoming exposed. If this is the case then a referral needs to be made to the brick manufacturer so that they can

confirm the brick service life will be not less than 60 years. The designer may wish to consider the use of “special-bricks” provided specifically by the manufacturers to create the selected pattern.

For the avoidance of doubt, the brick manufacturer should confirm the expected durability of the product in the proposed use so that it will meet our warranty service life requirement of 60 years.
