## Introduction

## Increased risks created by ponding

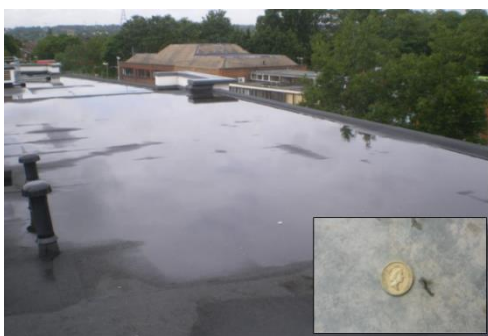
Flat roof areas that are being subjected to ponding water will have an increased risk of –

Punctures of a roof membrane are an issue irrespective of their position. However, if the roof should be punctured or damaged in a ponded area, standing water can build a head of pressure, which can facilitate faster water flow into the building below as well as damaging the structure.

The effect of ponding water creates an increased loading. As the depth of ponding water increases, more weight is applied and the deflection increases. This continues until damage occurs to the deck or remedial work is taken to alleviate the issue.

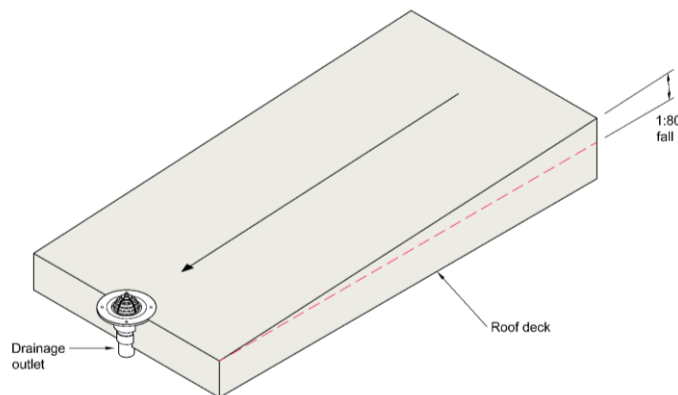
It is normal practice for a flat roof, having a pitch not greater than  $10^\circ$ , to have design falls of 1:40 which achieve 1:80 in service. This allowance is given to allow for site inaccuracies and minor deflections in the deck. Resultantly where this final 1:80 is not achieved, ponding water can occur. The image below illustrates the achievement of correct falls to the outlet.

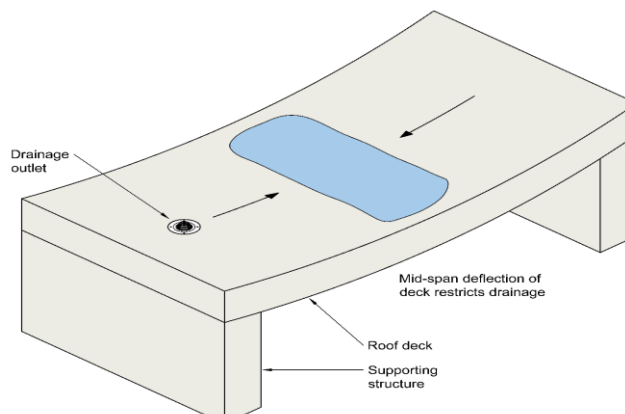
Where outlets are positioned close to supporting structure e.g. outside walls, columns or internal load bearing walls, a natural deflection at deck mid span can result in the outlet being higher than the main area of the roof which creates an area for ponding to occur.

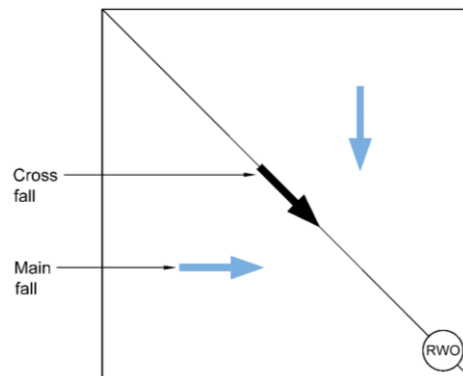
At the junction of two roof surfaces with different directions of fall, a valley will be formed, known as a cross fall. The effective slope created at the cross fall will be less than that of the main roof falls. As an example, where a main roof fall achieves 1:80, the cross fall will only achieve 1:113. The cross fall must achieve 1:80 as a minimum.

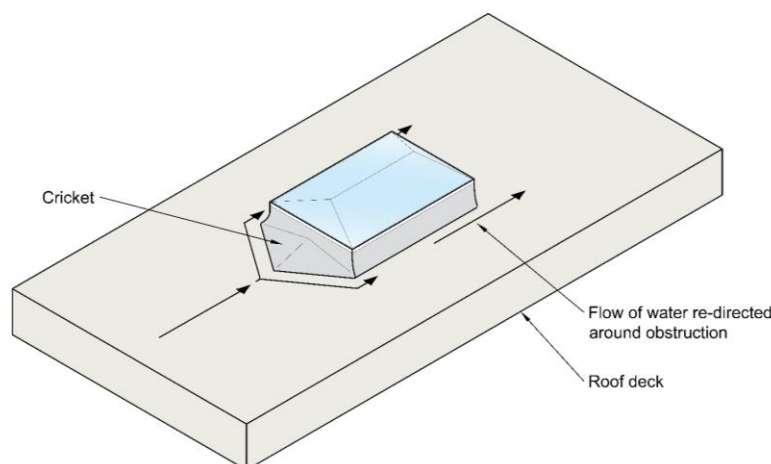
The position directly behind roof lights often gives rise to the opportunity for slowed drainage or drainage 'dead spots' where water ponds due to interruption of the roof fall. Drainage crickets are double triangle structures, constructed in the deck or sometimes provided by insulation to divert water around obstructions. Where these are not supplied, ponding will often occur.

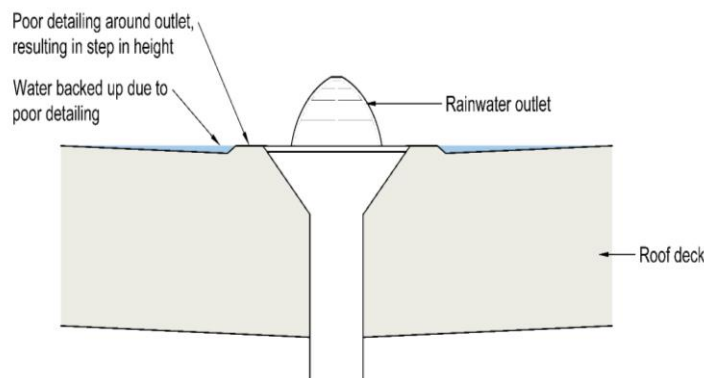
Outlets that are set too high in relation to the finished surface of the roof covering will often lead to ponding water. This is often a result of the detailing around the outlet being carried out after the main roof area is complete. When this happens, the formed lap creates a step in height. This can result in slowed water movement and a standing area of water that cannot naturally drain into the outlet. Plus, there is a potential for silt build up further adding to the problem.

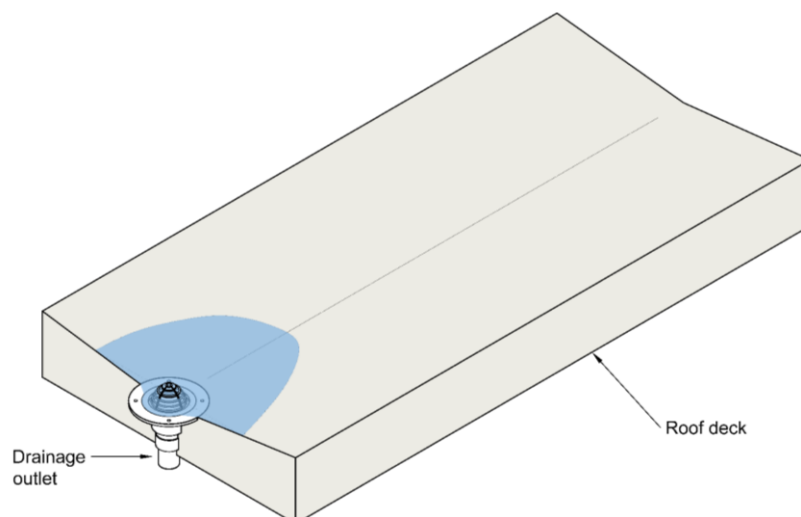
In instances where rainfall intensity increases over a short period, like flash flood conditions, the drainage capability of an outlet in normal circumstances can be rapidly reached and the water will pond over the area local to the outlet, creating a temporary natural sump.

It should be noted that this will only occur for a few minutes during a storm until an equilibrium state is reached and the water discharge down the outlets matches the rate of water arriving at the outlet. Correctly calculating the expected flow to the outlet and its capacity in accordance BS EN 12056-3 should ensure that any temporary build-up of water is reduced to a minimum.

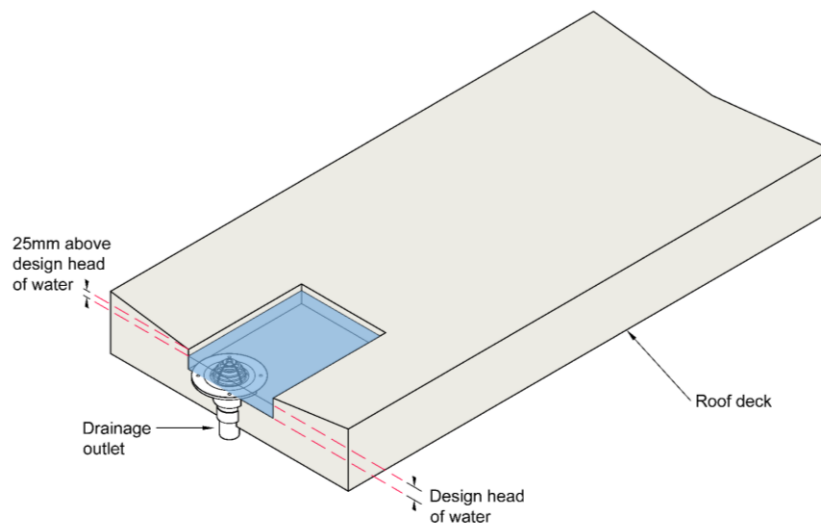
During a storm event these will fill extremely fast until the design head is reached. Once the equilibrium state is reached, with the water discharging down the outlets to match the rate of water arriving, sumps and gutters should then be free of standing water. The depth of a sump or gutter should be 25mm above the design head of water. Ponding water should not overtop the defined edge of the sump or gutter and spill out onto the roof slope.
